## Bush Beans Case Study

**Customer:** Bush Beans

**Application:** Steam Boiler

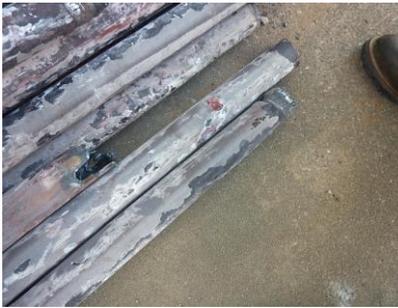
Boiler Tubes (before)

**The Challenge:** Bush Beans were experiencing significant scale accumulation on their fire tube steam boiler despite the use of scale inhibiting chemicals. Bush Beans adhere to a strict blow down schedule as part of their planned maintenance program.

Bush Beans had to take their boiler offline every 6 to 12 months in order to inspect and descale the water drum and tubes.

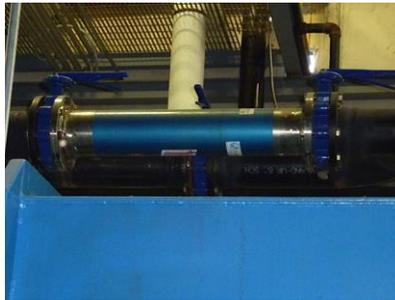
6" Colloid-A-Tron installation

**The Solution:** Fluid Dynamics were called in and having assessed the system recommended the installation of a 6" Colloid-A-Tron on the main feed to the boiler.

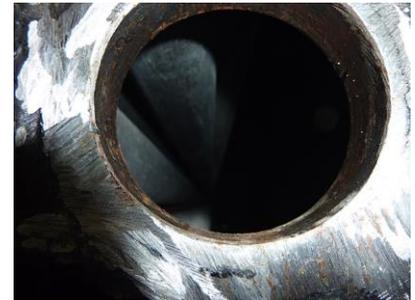
View inside the water drum (after)

**Results:** Following the installation, the boiler was opened up for inspection 6 months later. The reduction of scale was very apparent, any scale that was present was soft and easily washed away without the use of chemicals whereas in the past chemicals and mechanical methods (chipping hammers etc.) had to be used to remove a hard scale accumulation. Bush Beans are delighted with the reduction in maintenance and associated down time. As expected, energy costs are down due to the savings associated with operating a scale free system.
