Shower Mixing Valve Case Study

Customer: Double Tree By Hilton, Port Huron, MI

Application: Scale prevention for a medium sized hotel

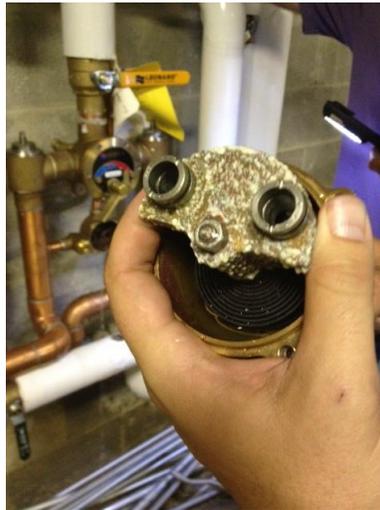
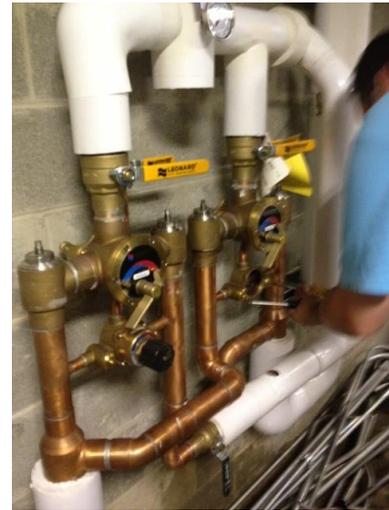
The Challenge: Though staff initially stated “We don’t have any issues with scale” this proved not to be the case. Contractors refurbishing the hotel were accommodated in 4 rooms and had been working at the property for just 4 weeks when newly installed shower fixtures started to malfunction. The Leonard mixing valve (shown above and to the left) was removed and large scale deposits were found.

The Solution: A Scaletron unit will be installed in the near future.
