Prepared for the US General Services Administration

Oak Ridge National Laboratory

January 2015

Catalyst-Based Nonchemical Water Treatment System Frank E. Moss US Courthouse Salt Lake City, Utah

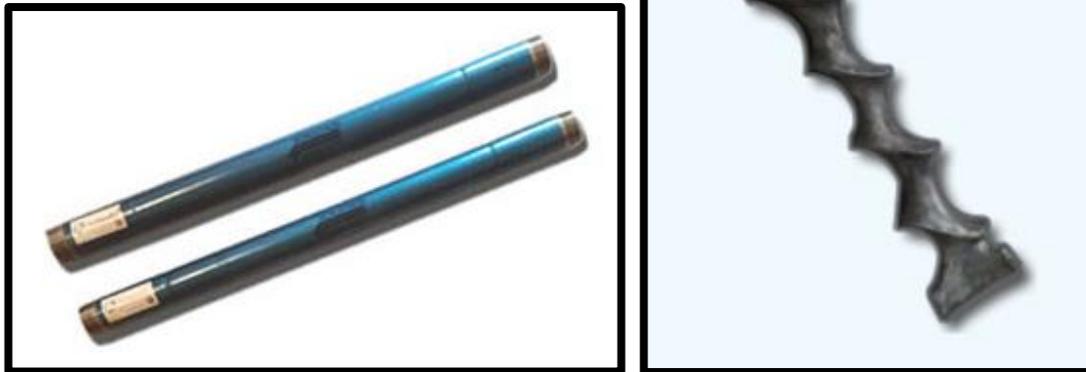
Figure ES-1 shows photographs of the device’s components. The image on the left shows what the exterior looks like. The image on the right shows the helical insert made out of the catalytic alloy. (Photo images were copied from the manufacturer’s website.)

Figure ES-1. Novel Nonchemical Water Treatment System. No external energy sources are required to operate this device. Periodic maintenance issues that must be addressed are also minimal. Once installed, the system operates as a stand-alone device. The vendor reports that the system has a service life of 15–20 years.

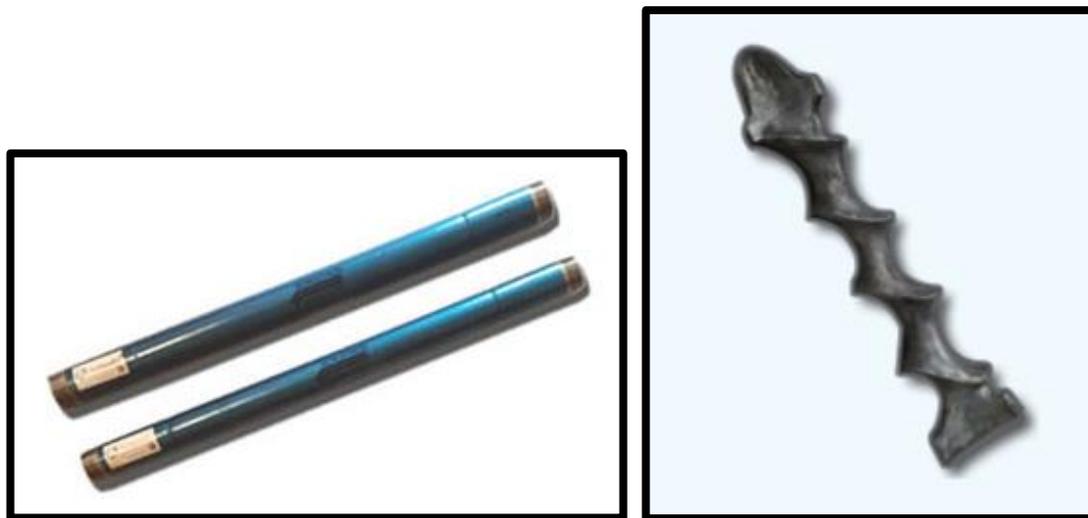
Inside the pipe is a fixed, immobile helical insert that is made from a proprietary catalytic alloy. As water passes through the pipe, the helical shape causes significant turbulence, which in turn allows water molecules and their associated chemicals to brush against the catalytic insert. According to the manufacturer, as water enters the pipe it impacts with the turbulator on the front end of the alloy. This turbulence causes calcium carbonate to form from the calcium and carbon in the source water. As this calcium carbonate forms and comes in direct contact with the alloy, the properties of the alloy cause it to

Figure 1 shows photographs of the device's components. The image on the left shows what the exterior looks like. The image on the right shows the helical insert made out of the catalytic alloy. (Photo images were copied from the manufacturer's website.)

Figure 1. Novel Nonchemical Water Treatment System. No external energy sources are required to operate this device. Periodic maintenance issues that must be addressed are also minimal. Once installed, the system operates as a stand-alone device. The vendor reports that the system has a service life of 15–20 years.

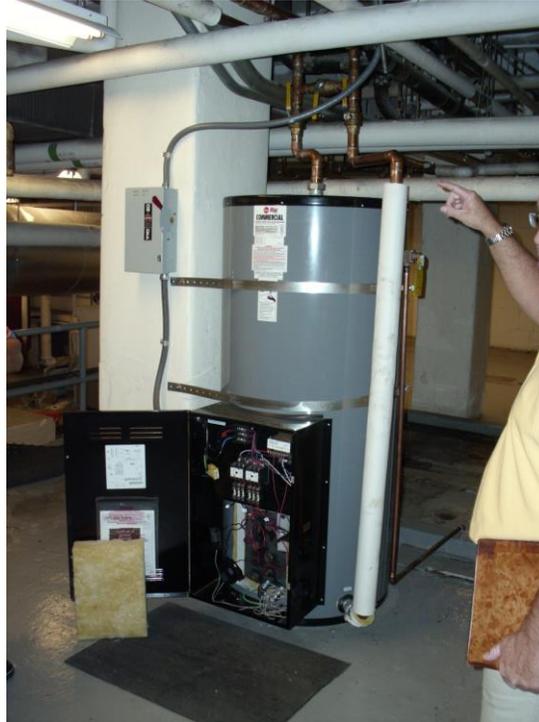
Figure 2 is a photograph of the electric water heater where the test was conducted. The insulated line on the right side is where the system's cold and recirculating water enters the tank.

Figure 2. Electric Water Heater Where Test Was Conducted.

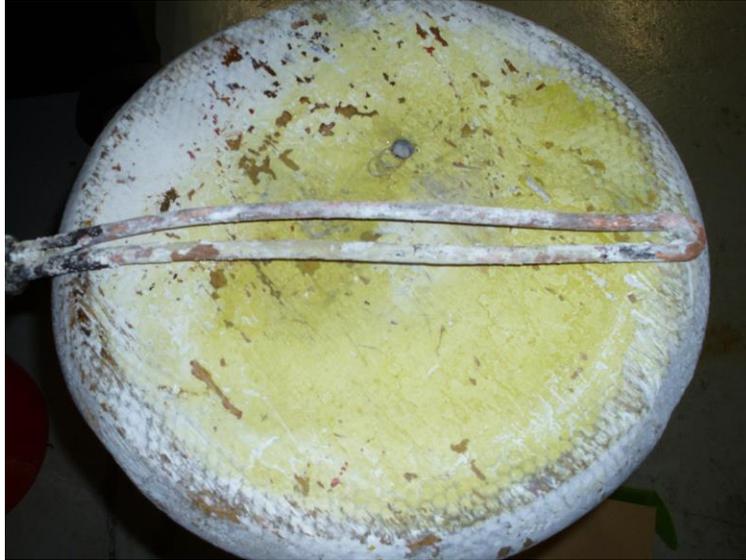
Figure 3 is a photograph of one of the heating elements that was removed. Please note the extensive buildup of calcium, the warped shape due to overheating, and the burn-through near the base of the element that caused it to fail.

Figure 3. One of the Heating Elements Removed from the Electric Water Heater.

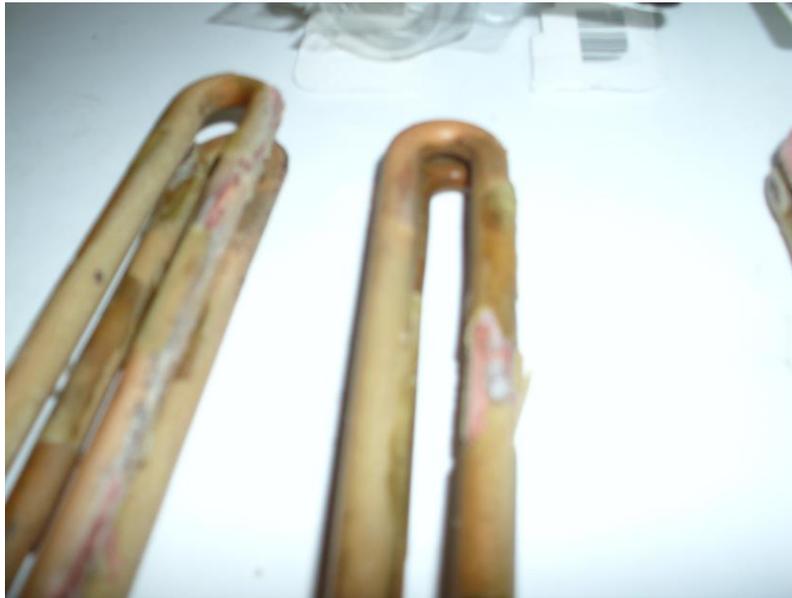
Figure 4 is another photo of a heating element taken at the moment it was removed from the tank. Please note the thickness of the calcite coating. It appears green in this photo due to it still being wet. This buildup was caused after just two months of operation in the tank.

Figure 4. Heating Element Removed from the Electric Water Heater.

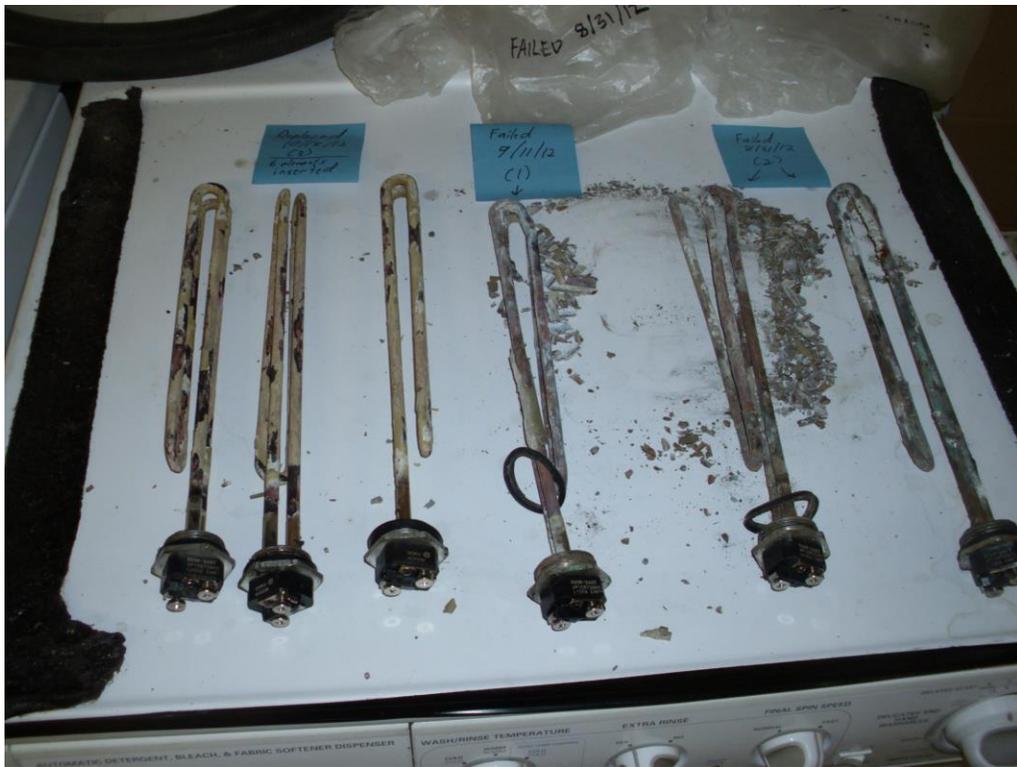
Figure 5 shows all six heating elements, which were removed by site operations personnel during one of the repair sessions. Three elements had failed, and all were severely coated with calcite.

Figure 5. All Six Heating Elements Removed from the Electric Water Heater During a Repair Session.

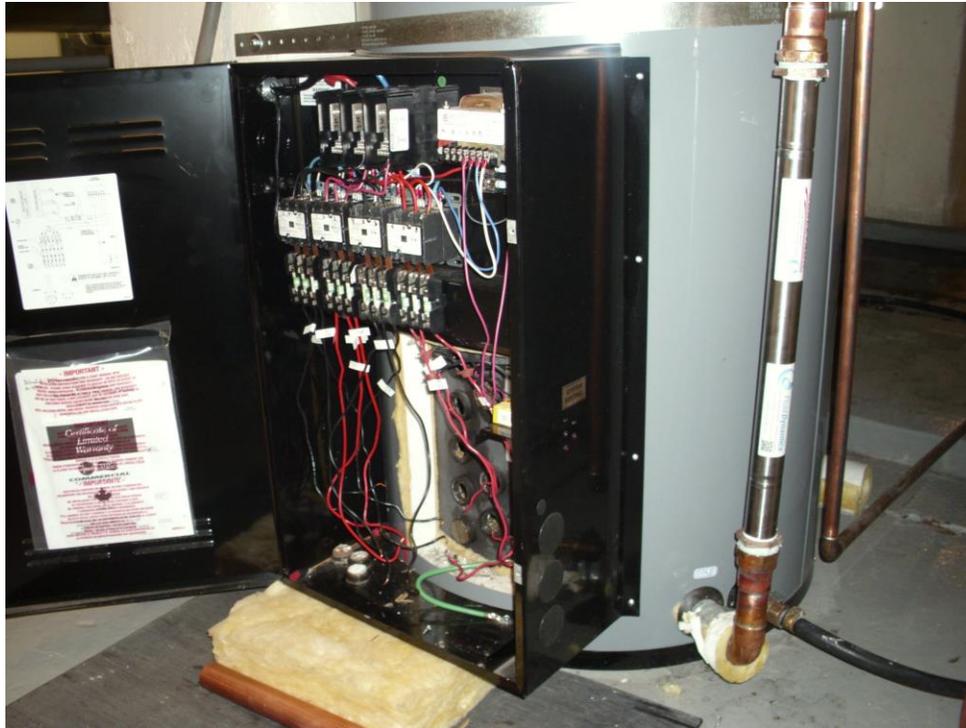
Figure 6 shows the device in its final configuration. It is the silver section of pipe on the right side of the black panel box. This is the cold water inlet to the water heater tank.

Figure 6. Final Configuration for the Nonchemical Water Treatment System (silver section of pipe on the cold water inlet to the water heater tank).

Installation of this technology is very straight forward. A section of the cold water and recirculating line was removed, appropriate pipe fittings were installed, and the technology was installed just as any pipe spool piece would be installed. Labor to install the device was only \$500 (10 person-hours at \$50/hr).

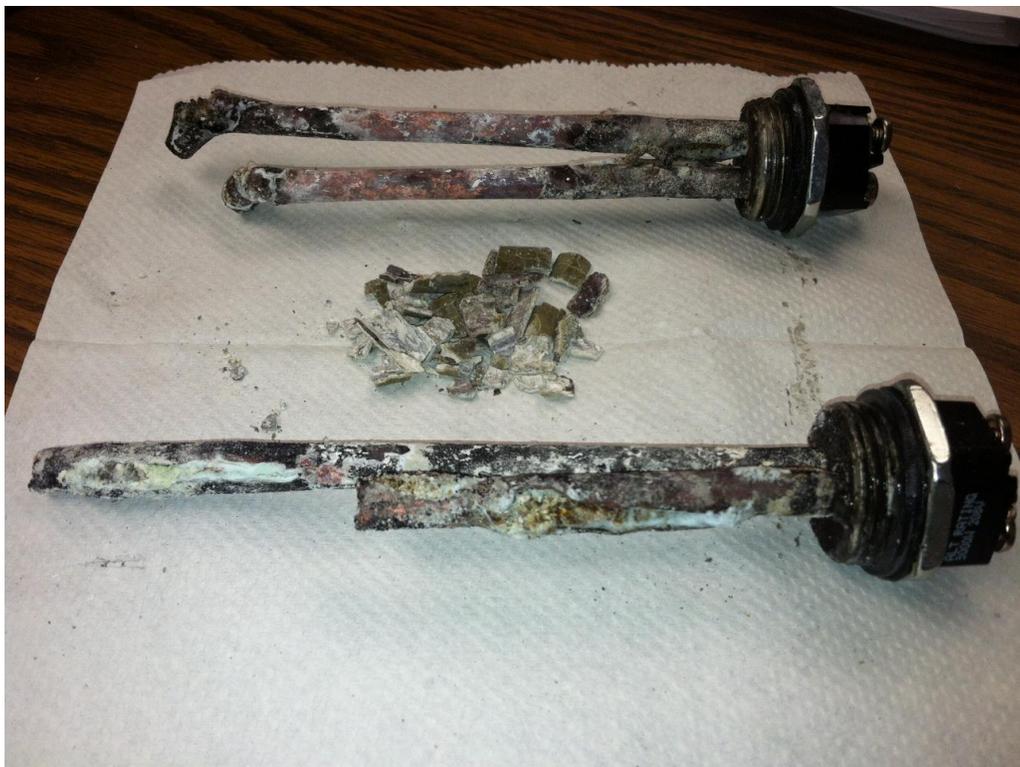
In December 2012, the GSA building manager contacted ORNL to say that it appeared that all three elements had again failed and ask for further guidance on what to do. After consultation with the project team, the elements were removed and their condition documented. Figure 7 shows two of the three failed elements.

Figure 7. Two of the Three Failed Heating Elements from December 2012.

The failure mode was the same as during the “before” test. Excess calcium buildup caused overheating and premature failure of the elements.

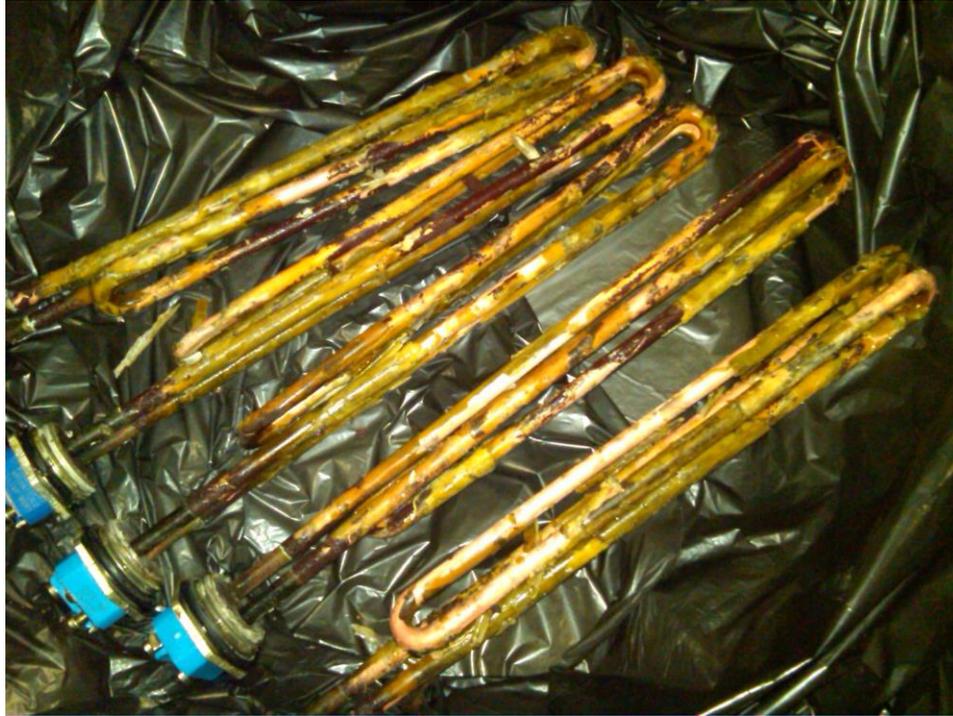
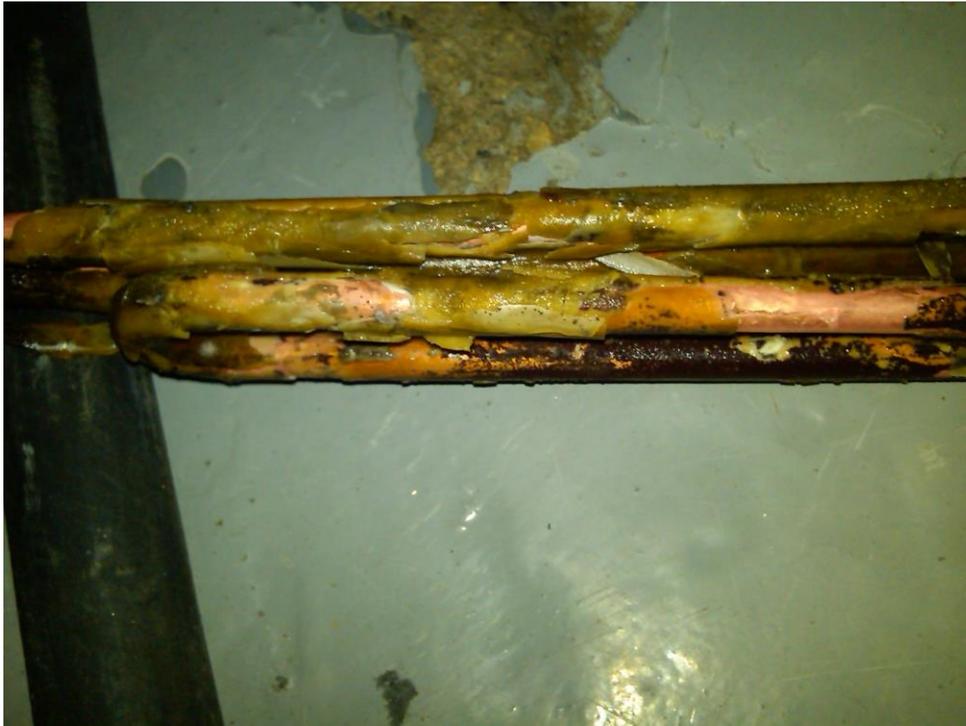
The heating elements that were removed all showed severe buildup of calcite, and this was after only two months of operation. They also showed signs of overheating and bending, which are precursors of failure (Figure 8).

Figure 8. Heating Elements Removed June 2013.

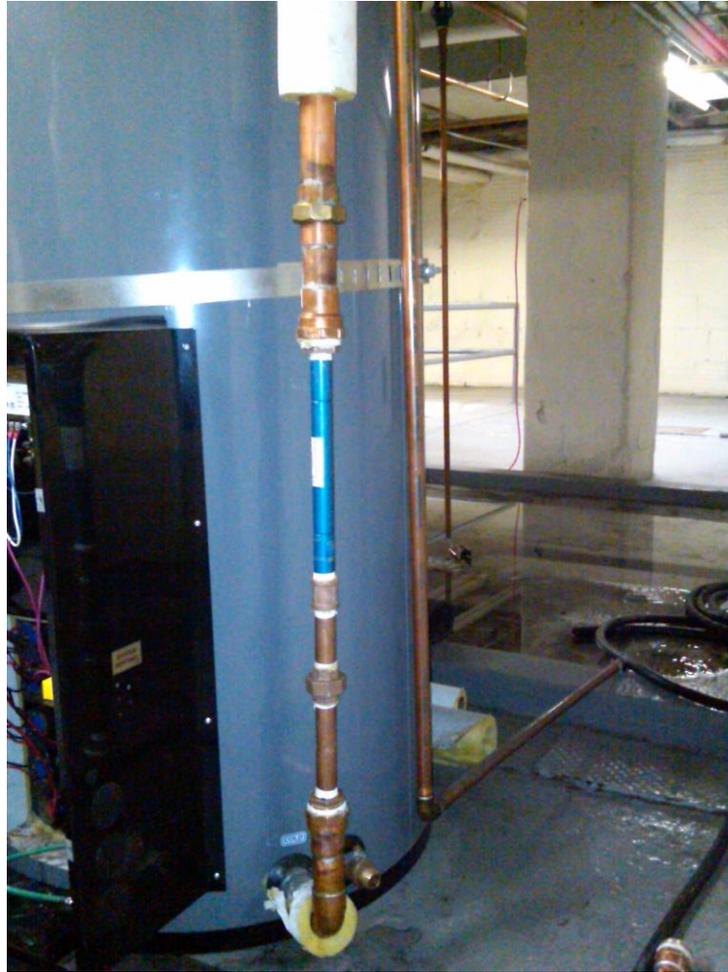
Figure 9 shows the 0.75 in. device installed where the 1.25 in. device had been located.

Figure 9. Electric Water Heater Showing the 0.75 in. Device (blue) Installed on the Cold Water Inlet Pipe.

On June 11, 2013, the team convened in Salt Lake City to remove the elements from the “before” period and to install the 0.75 in. device where the previous 1.25 in. device had been. At this point the “after” period of the test would begin.

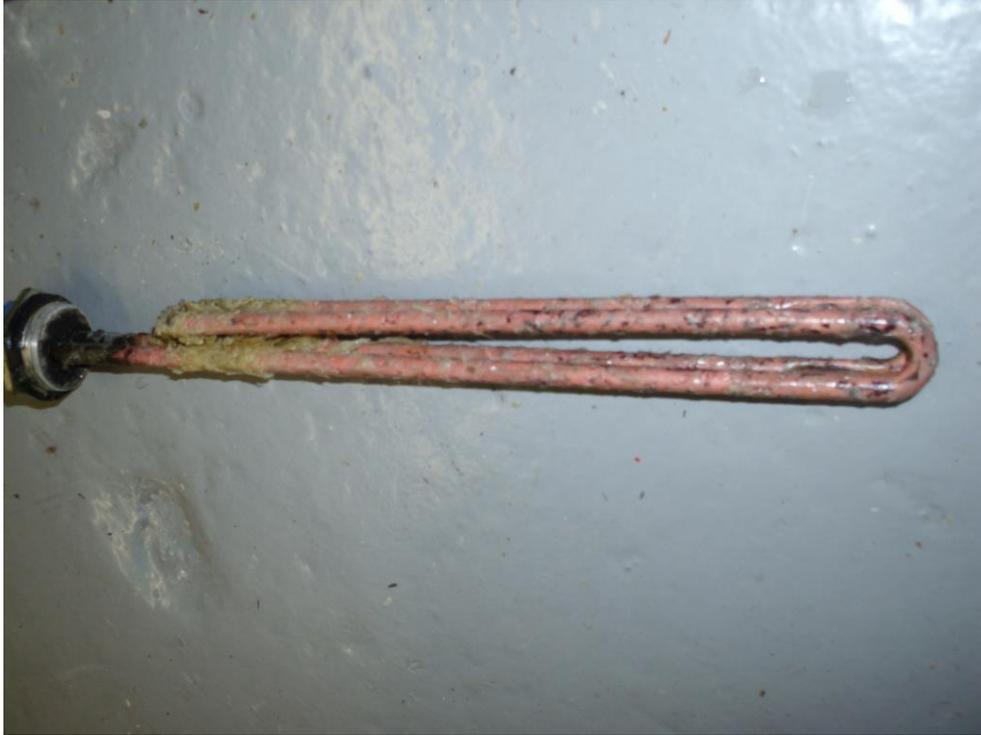
On August 20, 2013, the team met in Salt Lake City to examine the elements for calcium buildup. The six elements were removed, and they were indeed dramatically cleaner than had been seen in the past. Most of each element was bare metal with no buildup whatsoever. What calcium was found on the elements was in the form of very thin flakes. Also, there was no evidence of overheating or warping, which indicates there is no reason to fear impending failure of these elements (Figure 12).

Figure 12. One of the Six Elements Examined August 20, 2013.

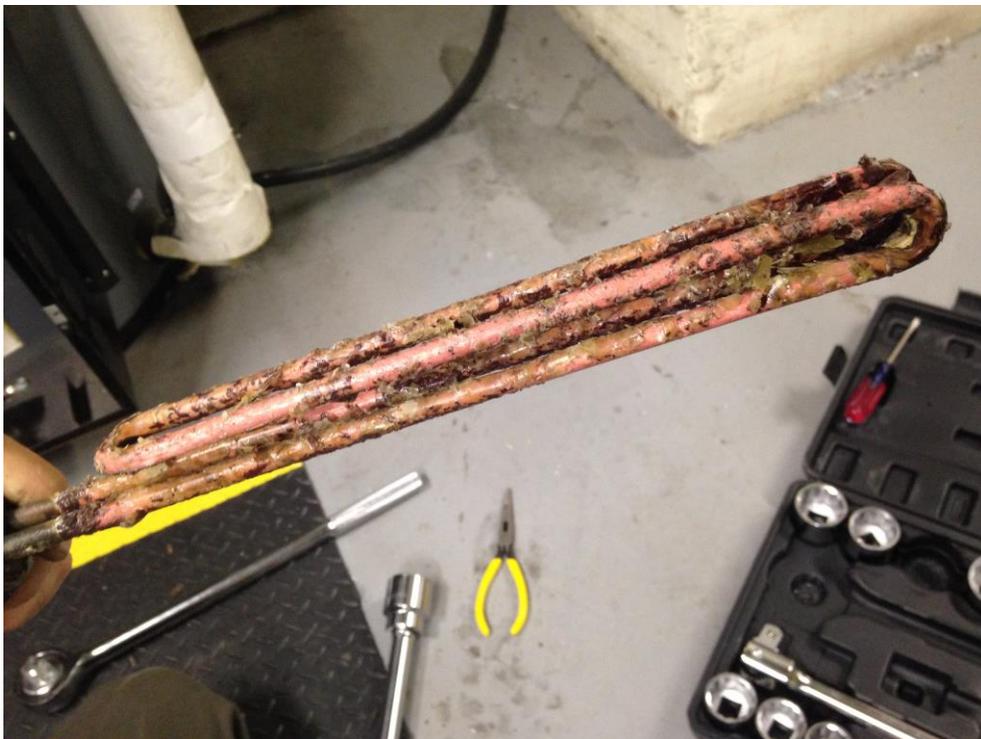
The tank was drained and heating elements removed for evaluation. There was some calcite on each element, similar to what was found in the July 2013 evaluation. However, the elements were mostly clean and in good condition. Figure 13 shows a typical element.

Figure 13. One of the Six Elements Examined in November 2014.

On November 20, 2014, the project team had the opportunity to reconvene at the site to evaluate the technology's long-term effectiveness after 17 months of continuous operation. During this period, no heating elements had failed.

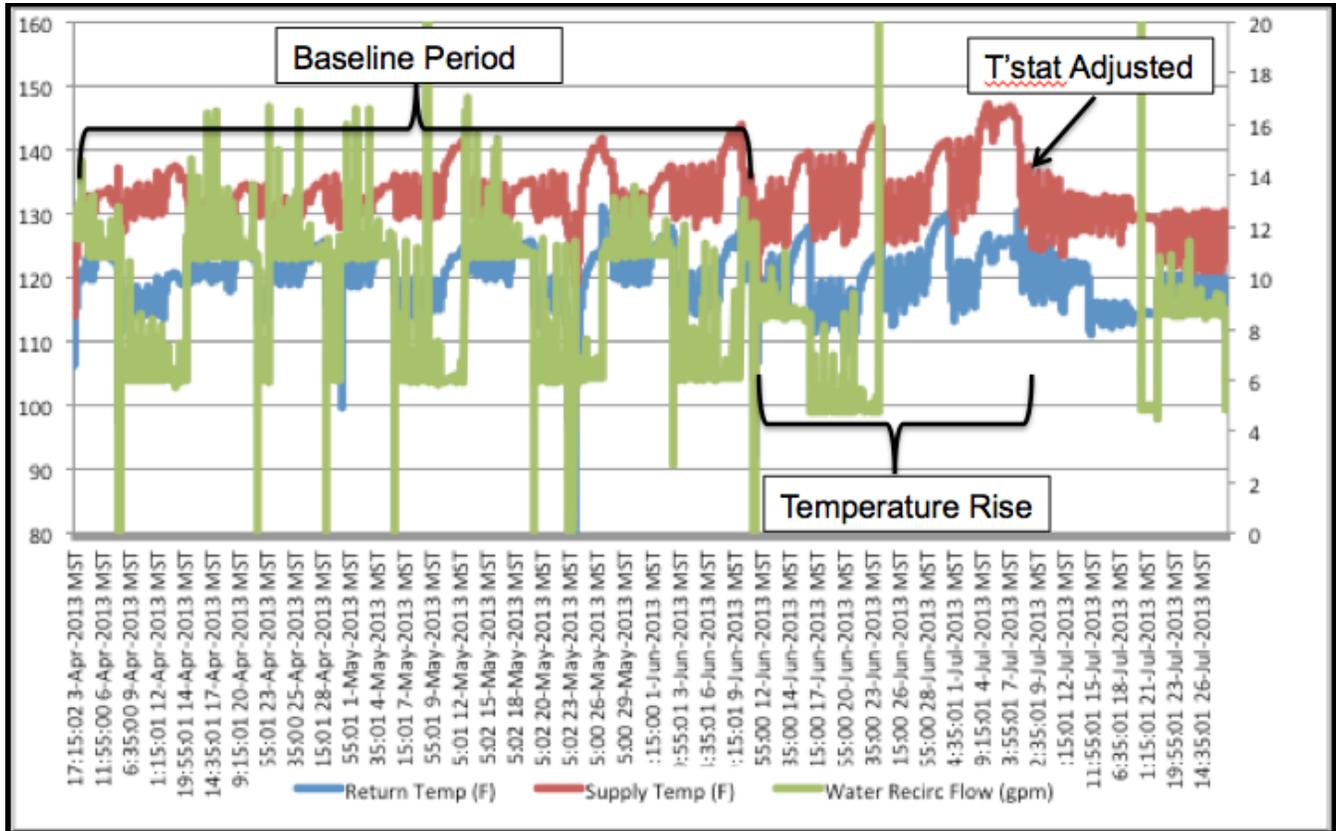
B. Enlarged Flow Rate and Temperature Graph

The following is an enlarged image of Figure 10 from the main body of the report. It is being shown here for clarity's sake.
